## **Minimum Thickness of Concrete Pavement for the F-15 and C-17 Aircraft**

Carlos R. Gonzalez, Walter R. Barker, and  
Alessandra Bianchini

July 2013

Final report

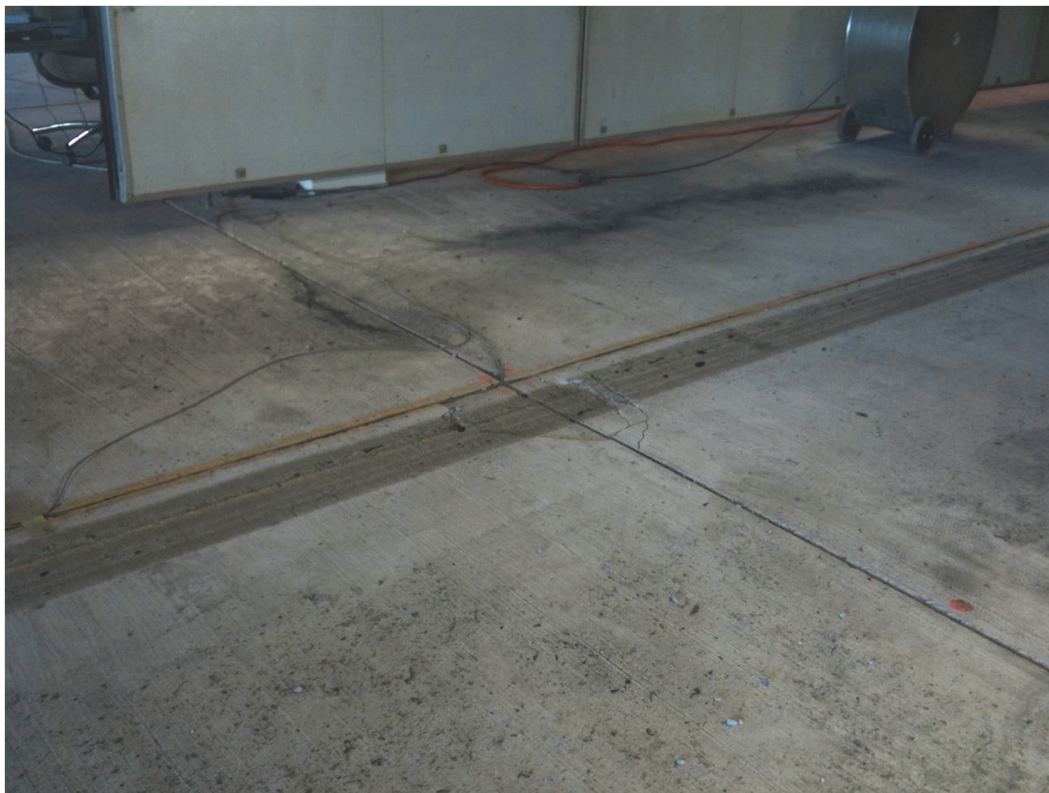
Figure 39. Corner break in Lane 1 Item 3 at 25,000 passes.

After the 11-in. pavement of Item 1 sustained such a high volume of traffic, the HVS-A was moved to the 8-in. pavement of Item 3, where the F-15 single-tire traffic was applied along the longitudinal joint. Corner breaks appeared on Item 3 at 18,000 passes. Item 3 reached the shattered slab condition after applying 25,000 passes (Figure 39). The shattered slab condition was defined when both corners contained multiple cracks and the slab was divided into four or more pieces. Traffic continued to 50,000 passes when it was terminated. There were no mid-slab cracks. Figure 40 shows a corner break after 300 B-52 passes. Figure 41 shows a corner break at the conclusion of traffic.

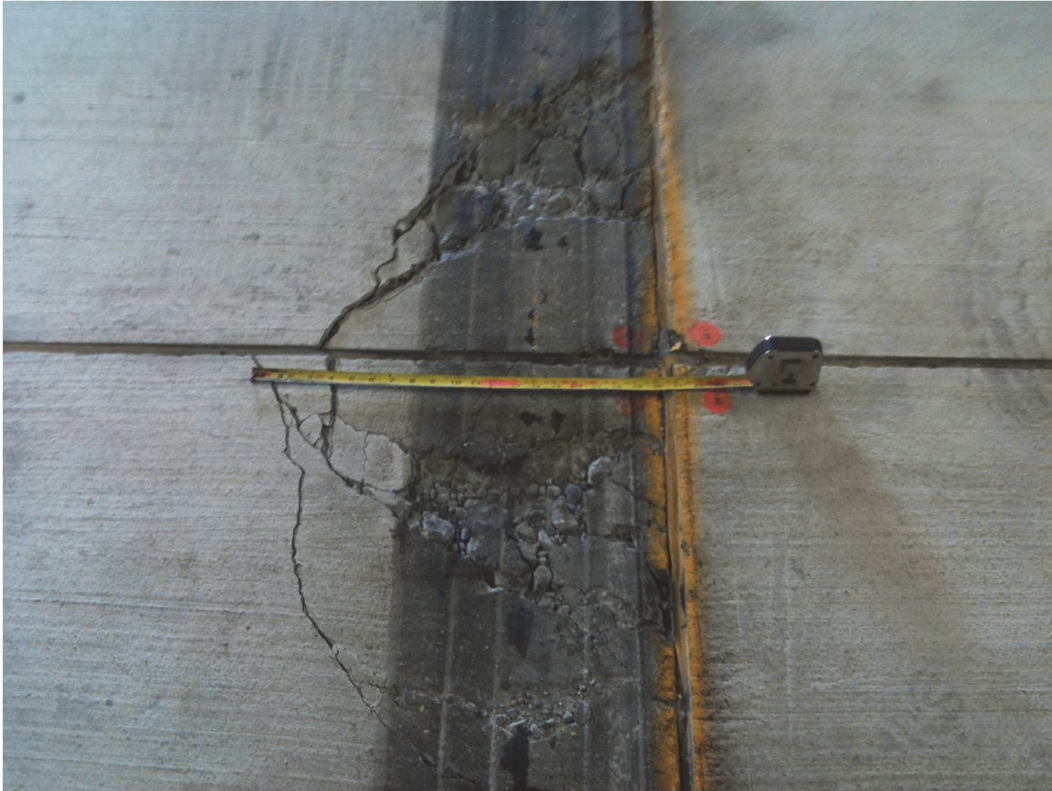
Figure 40. Corner break at 300 passes of B-52.

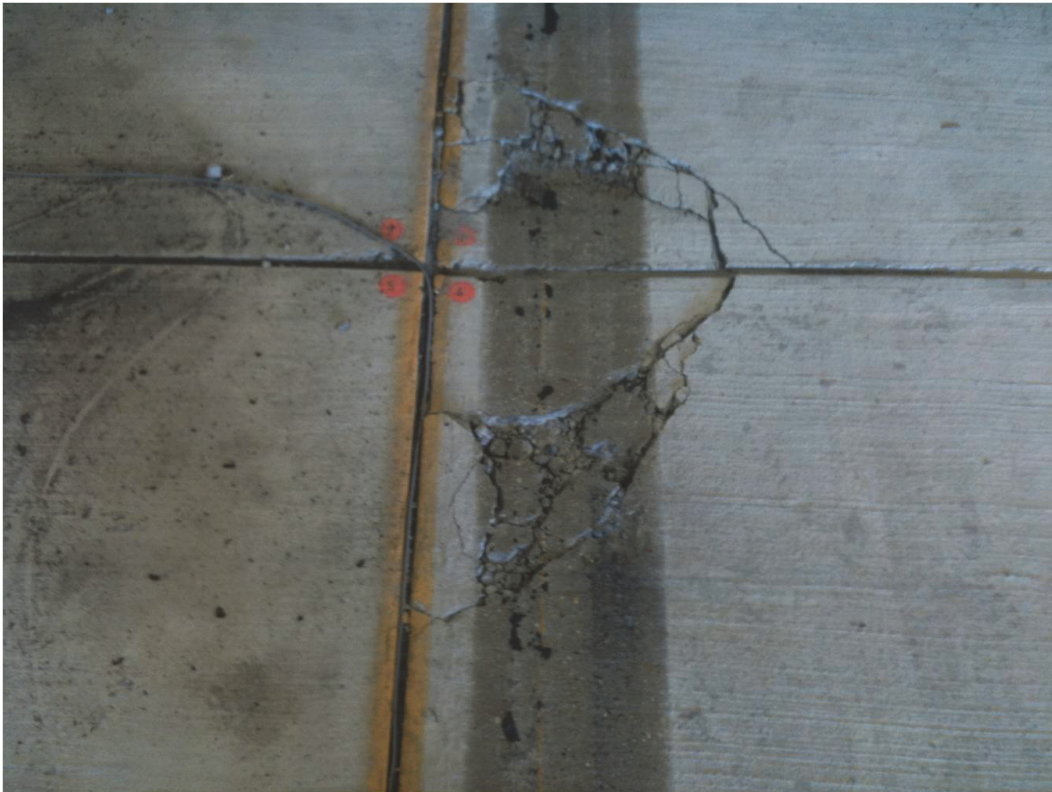
Figure 41. Lane 1 Item 3 corner break at conclusion of traffic (50,000 passes).

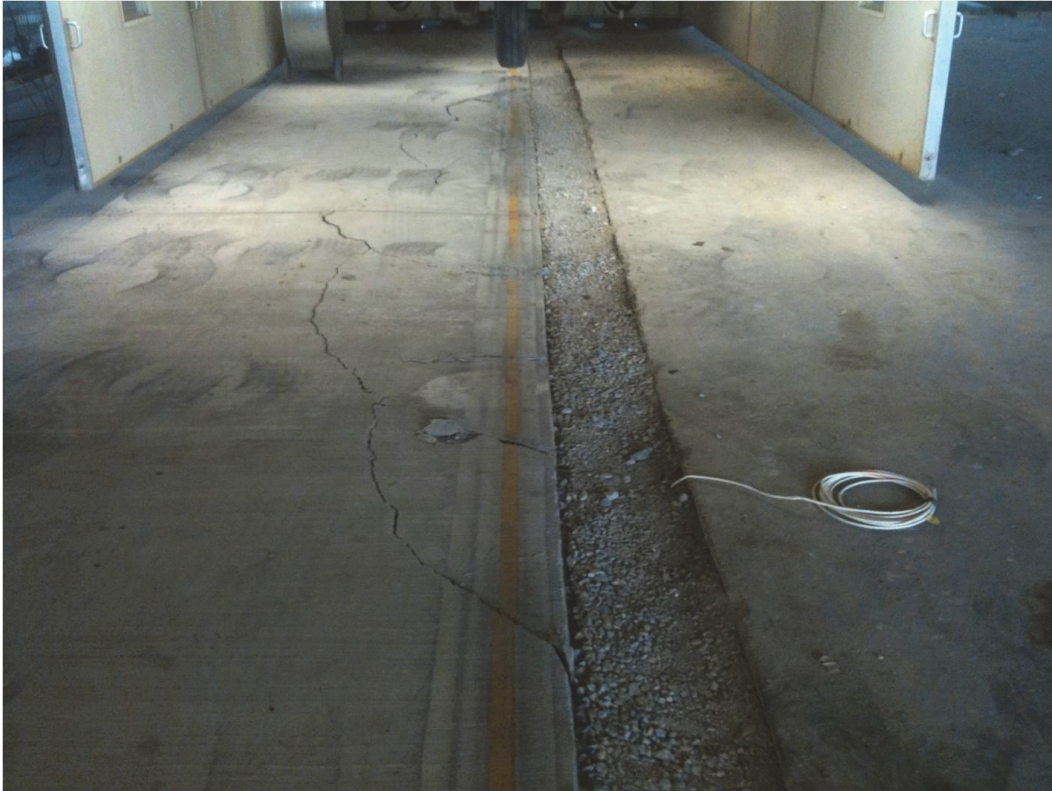
Figure 42. Lane 2 Item 3 at 1,000 passes of the F-15 tire.

The F-15 traffic was first applied on Lane 2 Item 3 (8-in. slab thickness). The first crack occurred at 141 passes. At 500 passes, Item 3 was considered to have sufficient cracking to be in a shattered slab condition. Figure 42 shows the condition of the slabs after 1,000 passes, at which time the traffic was terminated.

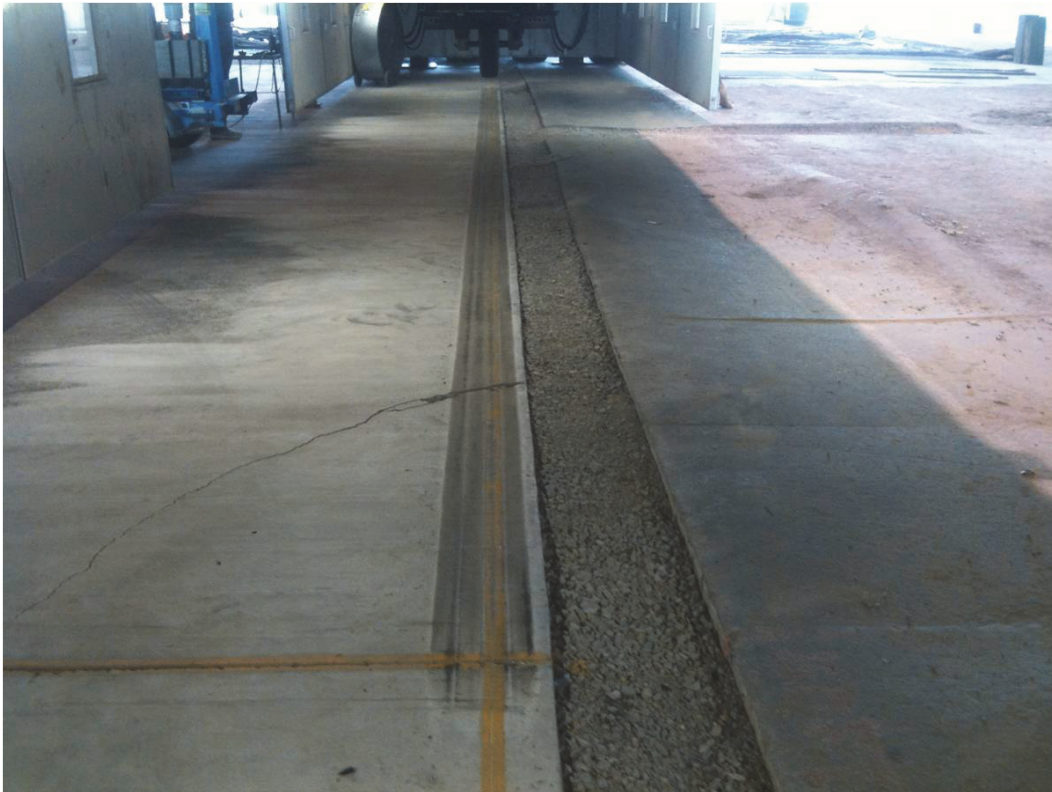
Figure 43. Lane 2 Item 1 at 15,000 passes of the F-15 tire.

After termination of traffic on Item 3, the HVS-A was moved successively to Item 1 and then to Item 2. On Item 1, a corner break developed at 300 passes but the crack did not progress to a shattered slab condition. No other cracks developed prior to termination of the traffic at 25,000 passes. Figure 43 shows the condition of the test section at 15,000 passes.

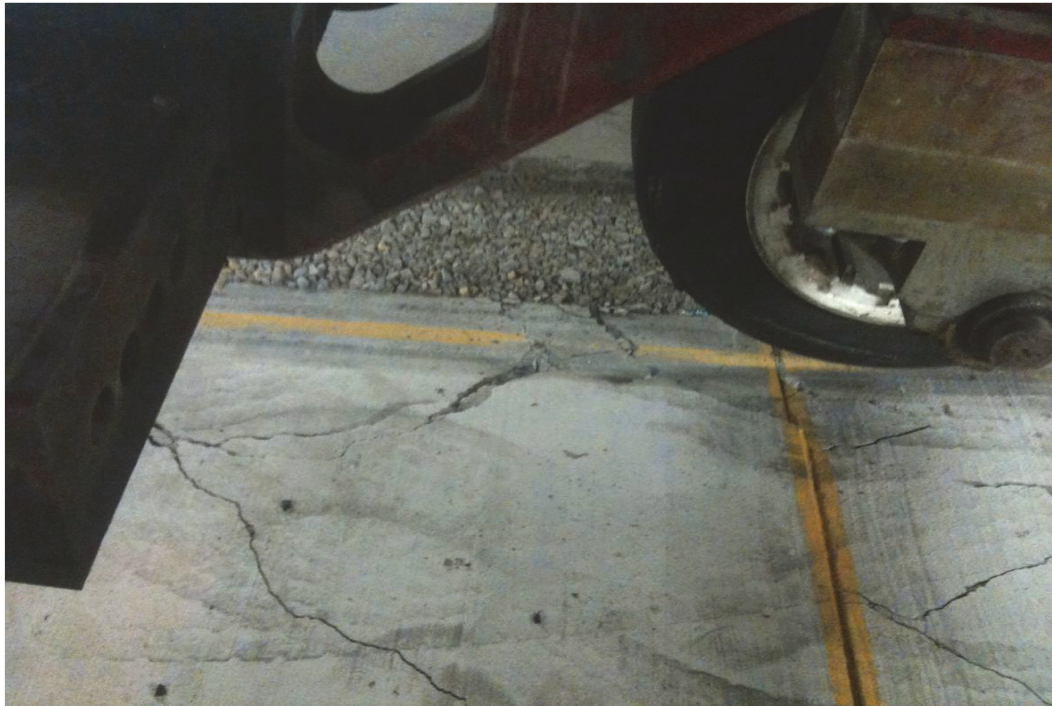
Figure 44. Corner break at transition joint between Items 2 and 3 at 1,303 passes.

After trafficking Item 1, the HVS-A was moved to Item 2. After 504 passes, a corner crack developed at the transition joint between Items 2 and 3. The difference in slab thickness between Item 2, with 11-in. slabs, and Item 3, with 8-in. slabs, caused a discontinuity at the joint between the two items. Pavement deterioration was rapid at the corner break where a shattered slab condition was reached at 700 passes. At 1,303 passes, termination of traffic was necessary due to the corner break, which posed a risk to the tire (Figure 44). However, for Item 2 there were no additional cracks other than the corner break.

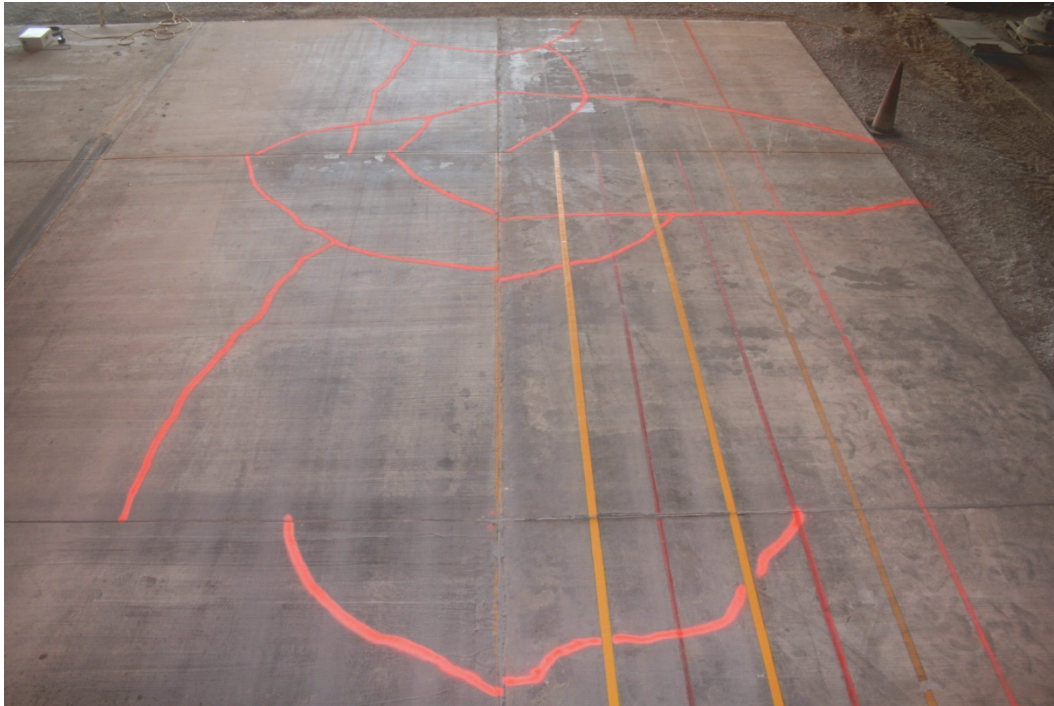
Figure 45. Cracking pattern for Lane 3 Item 3 at 500 passes.

occurred on Item 3 (8-in. slabs) after 8 passes. The first crack, a corner break, was of a different nature than the corner breaks resulting from single-wheel traffic. The corner breaks from the single-wheel traffic began at the dowel closest to the corner and advanced to the transverse joint about 1 ft from the corner. The corner break in Lane 3 began at the longitudinal joint at about 1/3 of the slab length from the corner and propagated to about mid-slab on the transverse joint. The location where the crack initiates corresponds with the location of the maximum tensile stress at the top of the slab. The maximum tensile stress would occur as one set of the C-17 tires is near the transverse joint and the other set is near the center of the slab. Item 3 was in the shattered slab condition after 308 passes. Figure 45 shows the cracking pattern at 500 passes for Item 3.

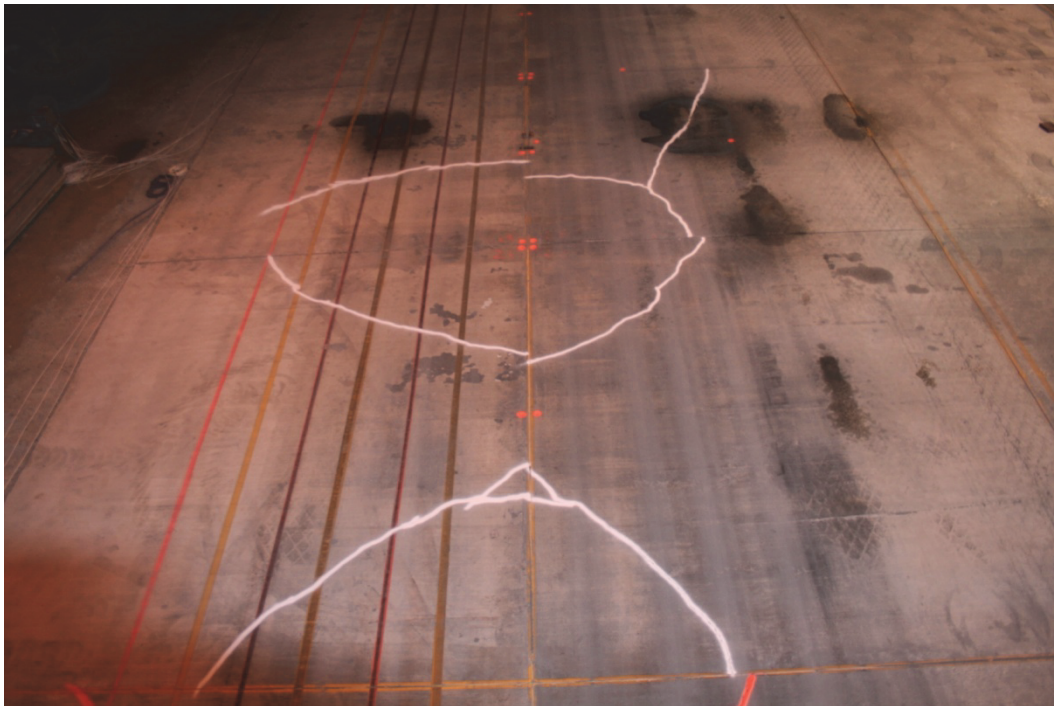
Figure 46. Cracking pattern for Lane 3 in Item 2 at 700 passes.

The first crack for Items 1 and 2 (11-in. slabs) were at 308 and 1,008 passes, respectively. The shattered slab condition was reached at 1,008 for Item 2, whereas Item 1 did not reach shattered slab condition before traffic was terminated at 2,000 passes. During the 2,000 passes, only two cracks appeared in Item 1. Figures 46 and 47 show the cracking pattern at 700 passes for Item 2 and one of the two cracks in Item 1, respectively.

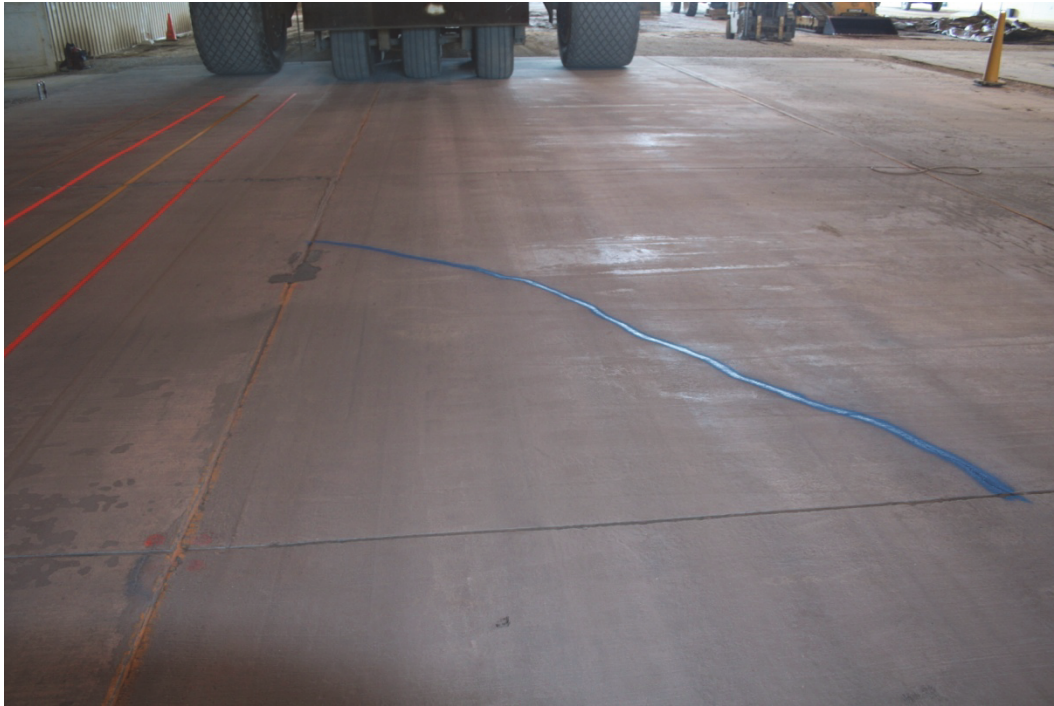
Figure 47. One of the two cracks in Item 1 – note load cart in the background.

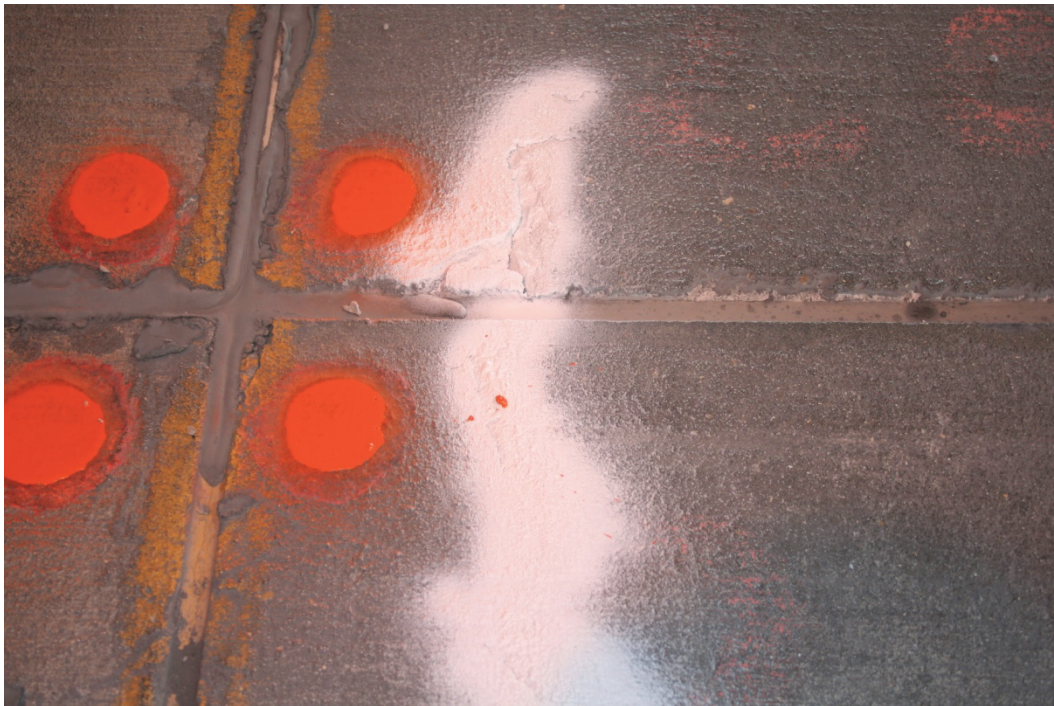
Figure 48. Spalling along the top of dowel in Item 2 (orange dots are FWD test locations).

Some minor spalling of the pavement occurred in Item 2 over a dowel near the corner (Figure 48).

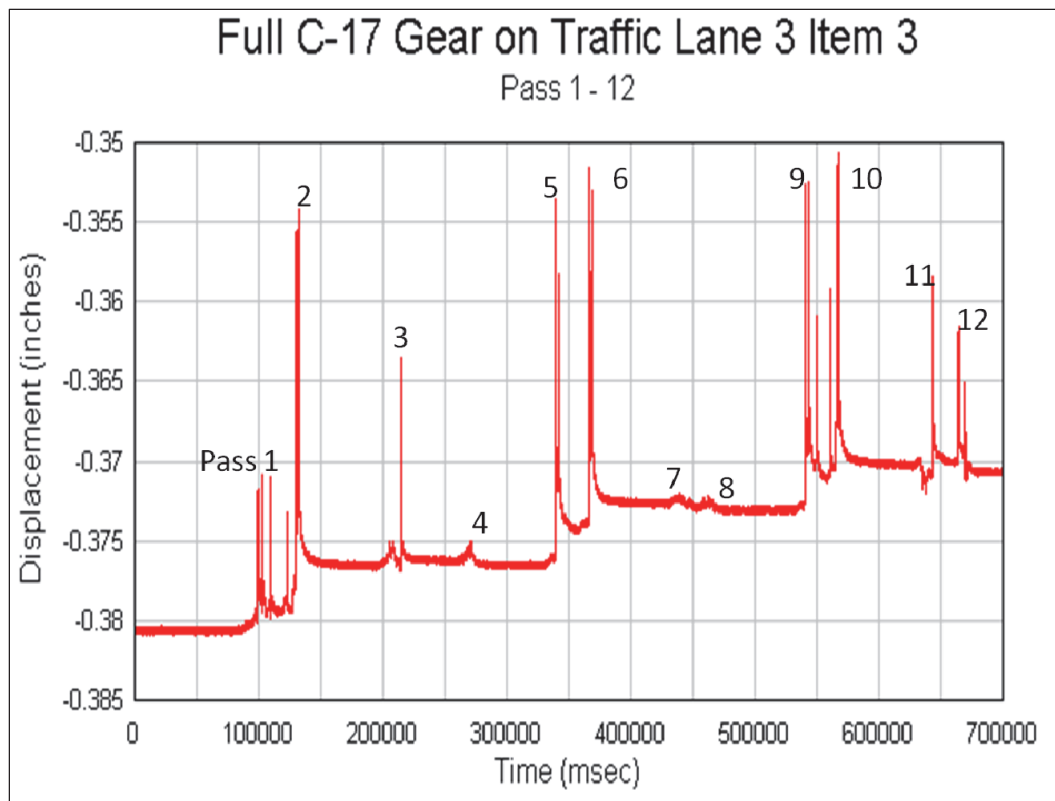
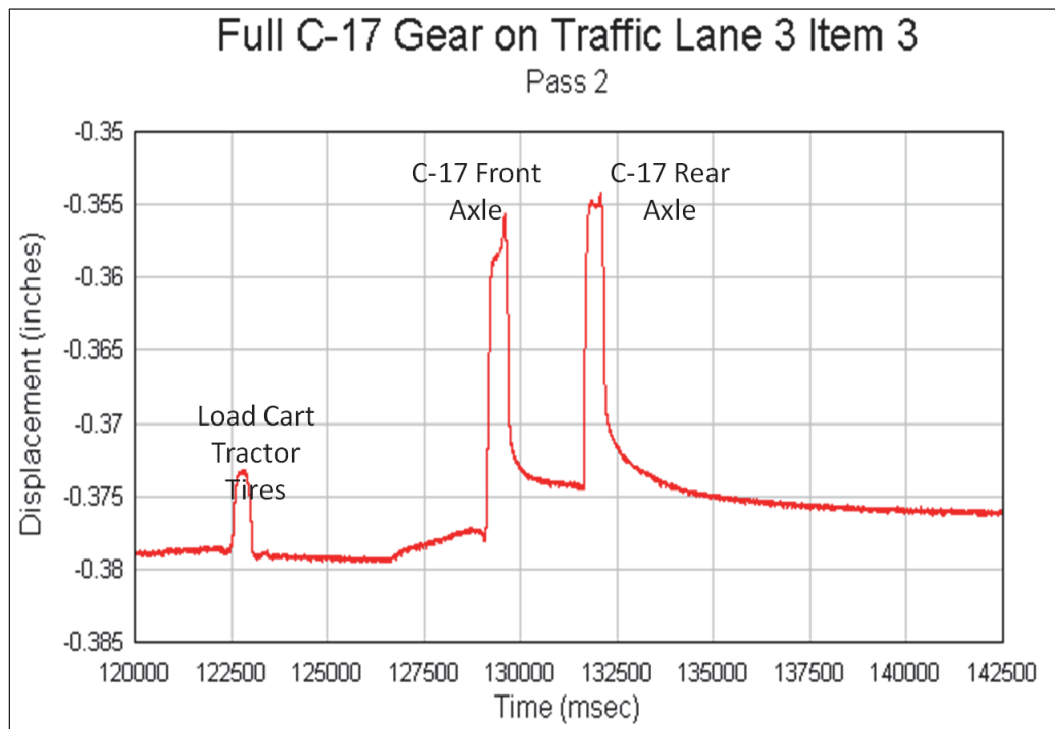
Figure 53. Data from the LVDT deflection gauge for Lane 3 Item 3.

Figure 54. Enlargement of the plot for the relative joint deflection for Pass 2 Item 3.

Figures 53 and 54 show the data for the relative longitudinal joint deflection in Item 3. As with the gauge response for Item 2, the maximum deflection of 0.021 in. occurred during Pass 2, which is greater than the maximum deflection in Item 2. In addition to having higher relative joint deflection, the permanent deformation that developed during the first 12 passes was greater in Item 3 than in Item 2. This was expected due to the reduced thickness of Item 3 as compared to Item 2.

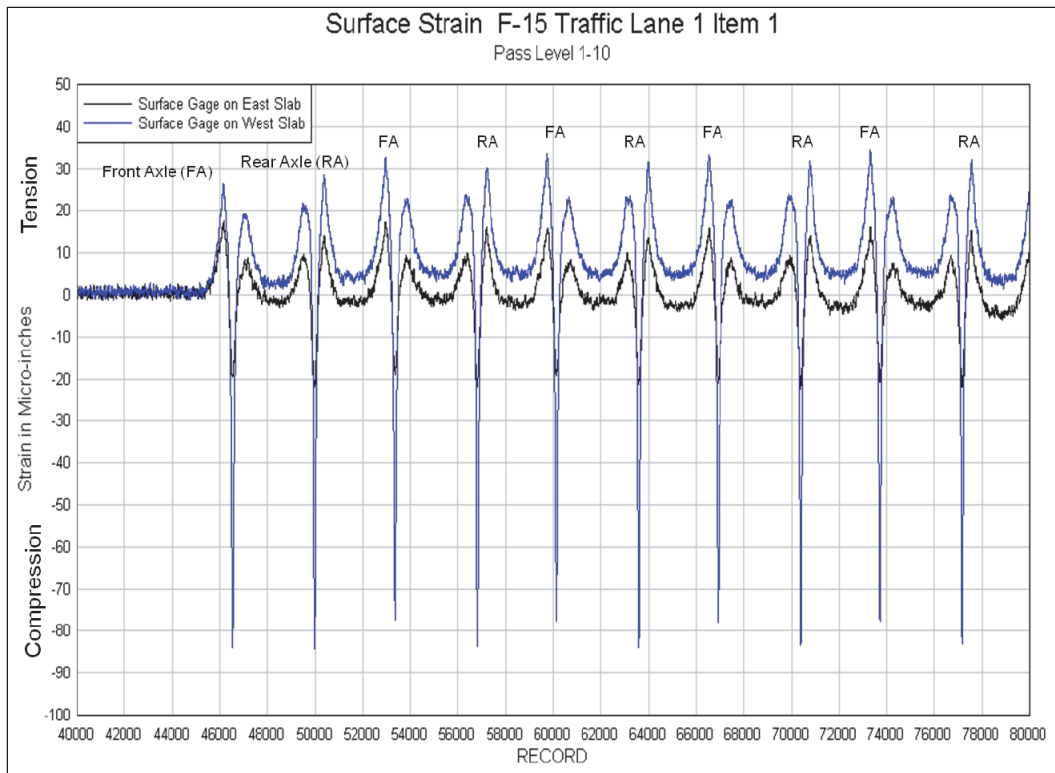
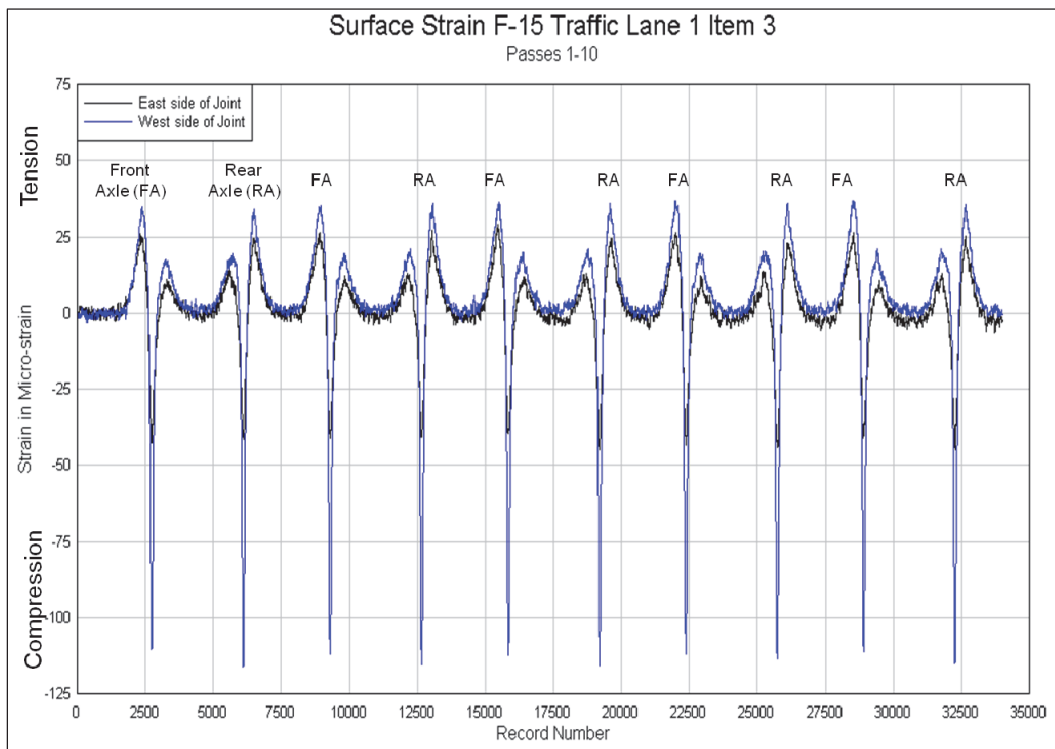
Figure 55. Surface strain gauge response traffic Lane 1 Item 1 Passes 1-10.

Figure 56. Surface strain gauge response traffic Lane 1 Item 3 Passes 1-10.

Figures 55 and 56 show the data from the surface strain gauge installed in Items 1 and 3 on Lane 1 (Figure 24). In these figures, positive strain represents tensile strain and negative strain represents compression strain. Although not all the gauges functioned properly, the data in Figures 55 and 56 appear to be an accurate representation of the strain distribution. Some of the malfunctions of the gauges on the vertical face of the longitudinal joint were most likely caused by moisture from the placement of the center lane. Many of the surface gauges malfunctioned early in the traffic testing due to tire abrasion. However, the gauges on Items 1 and 3 performed well.

Another aspect of the data is that strain changes from tensile strain to a compressive strain, as the tire approaches and moves over the gauges. This action results in a strain difference, from tensile to compressive strain that is significantly greater than just the measured tensile or compressive strain. In Figure 55, it is also noted that in Item 1 there is a small amount of permanent strain that develops during the first 10 passes. The magnitude of the permanent strain does not appear significant. However, no permanent strain was noted in Item 3.

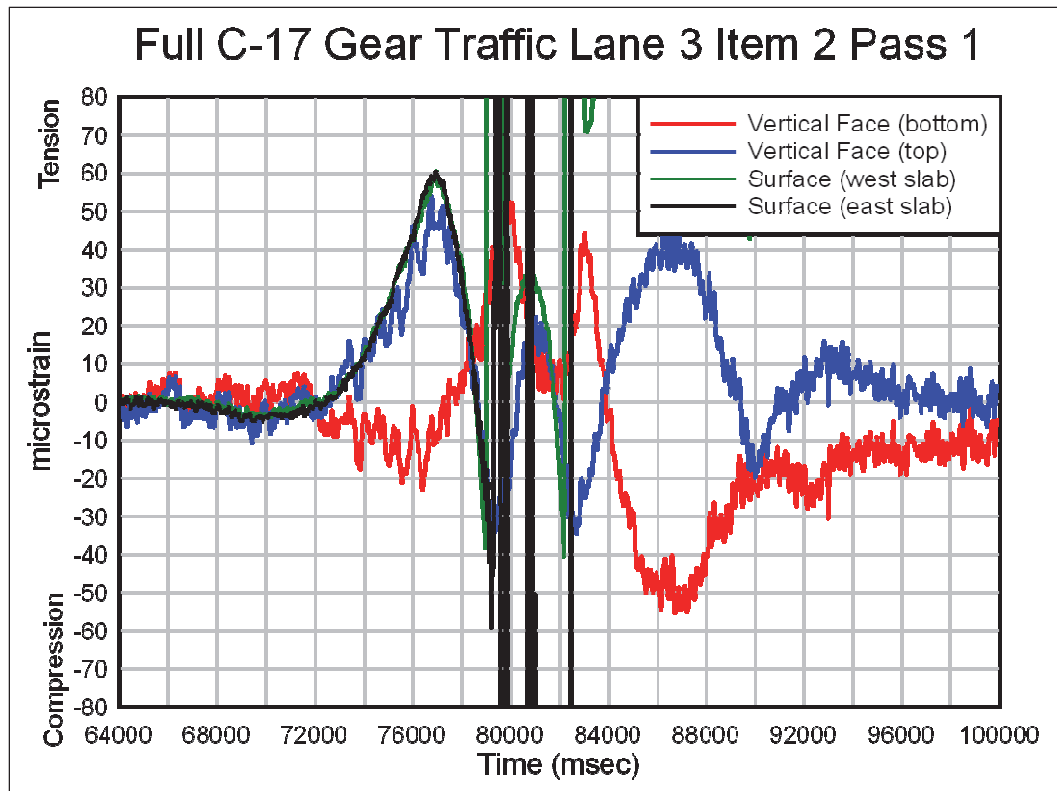
Figure 59. Strain gauge data for C-17 on Lane 3 Item 2, Pass 1.

Figure 59 shows the strain gauge data for the first pass of the C-17 gear on Item 2. These gauges were destroyed by abrasion from the C-17 tire. The data appeared good as the tire approached the gauge, but erratic readings were obtained when the tire crossed the gauge. The observed trends of Item 2 were similar to those for Item 1, although the data for Item 2 show larger tensile strains than those measured strains in Item 1.
